## CITY OF ROCKVILLE HISTORIC DISTRICT COMMISSION STAFF REPORT

## July 15, 2004 MEETING NO. 08-04

APPLICATION: HDC2004-00305

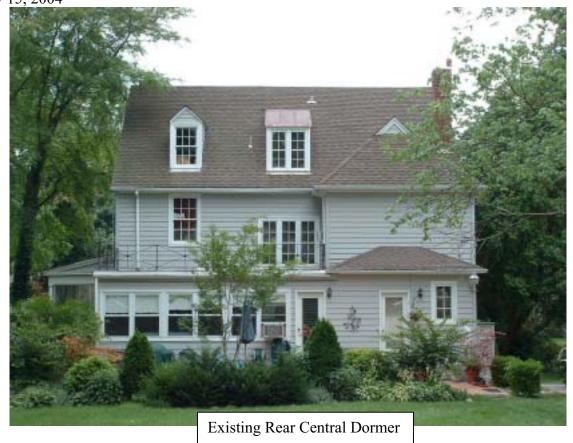
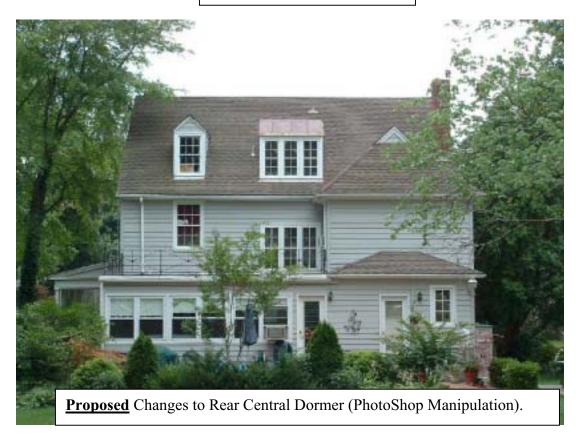
Regarding the rear dormer, the homeowner has stated that he intends to replicate the existing windows with the same materials, style, and craftsmanship. The dormer windows, as proposed, will mirror the 2<sup>nd</sup> story windows in design, material and scale.

Staff recommends the approval of the proposed dormer widening as appropriate to the style of the house and compatible with the existing materials and design. Staff finds that it will have no adverse effect on the character of the house or of the streetscape.

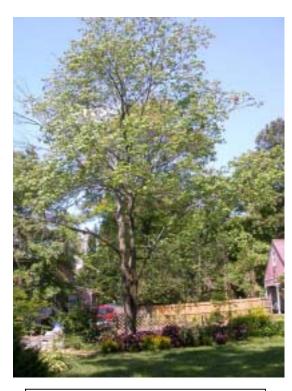
- # Black Gum in the rear yard is in poor condition and has structural issues
- # Maple in the rear yard by the driveway is declining/dying, likely girdling root and drought impacts
- # Black Cherry in the side yard is impacting the foundation of the house and is not of historical significance

Maple tree rear yard by driveway

Staff recommends approval of the removal of the three trees as stated in this application, as per the recommendation of the City Forester with the additional condition:
